YELLOW CREEK STATE PARK DAM
NDI I.D. NO: 282

PHASE I INSPECTION REPORT
NATIONAL DAM INSPECTION PROGRAM

D'APPOLONIA CONSULTING ENGINEERS
10 DUFF ROAD
PITTSBURGH, PA. 15235
SEPTEMBER 1978

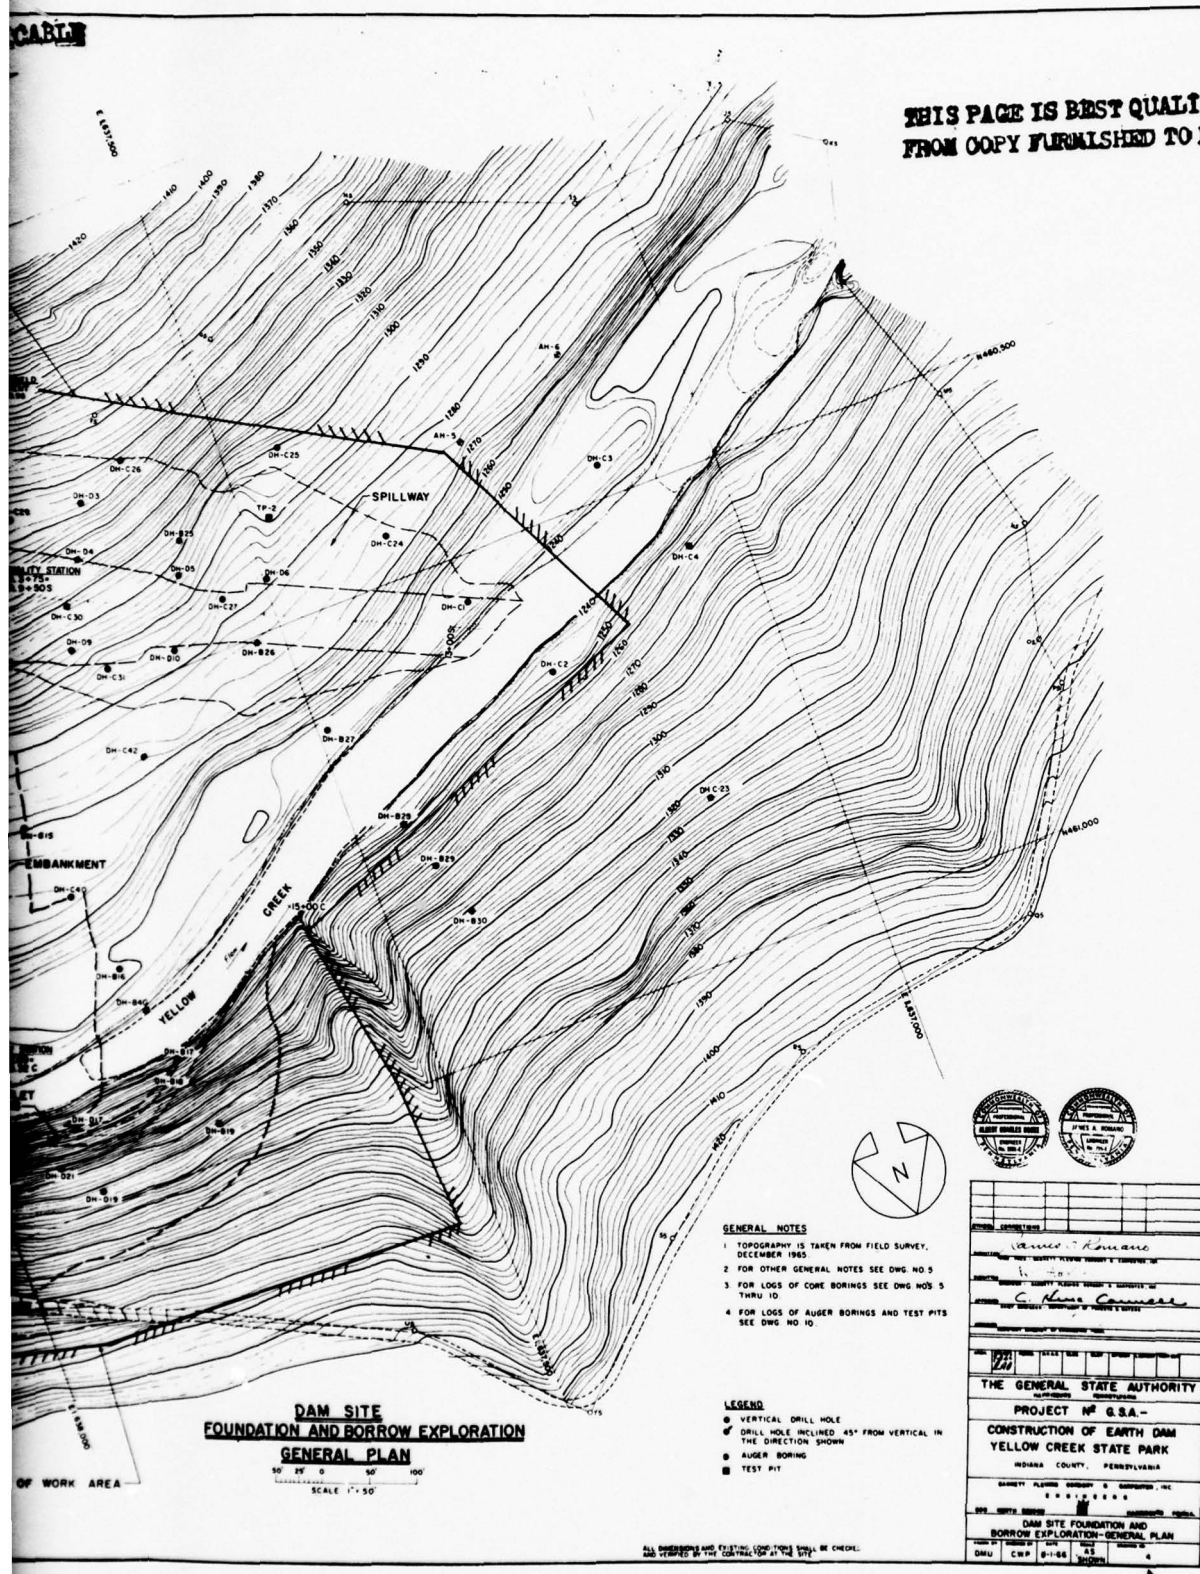
PLATE 4

VISUAL EXAMINATION OF	REMARKS OR RECOMMENDATIONS
JUNCTION OF EMBANKMENT AND ABUTMENT, SPILLWAY AND DAM	No signs of distress or seepage.
ANY NOTICEABLE SEEPAGE	A wet area located on the left side of the outlet conduit of the discharge channel. See Plate 4 for location.
STAFF GAGE AND RECORDER	Located in the outlet works control structure.
DRAINS	None
